Air Turbine Thermal Stability

November 2018

An investigation into temperature change of the Air Turbine Spindles over long running periods is required.

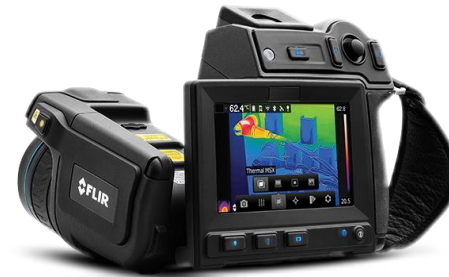
FLIR T640 Thermal Imaging Camera

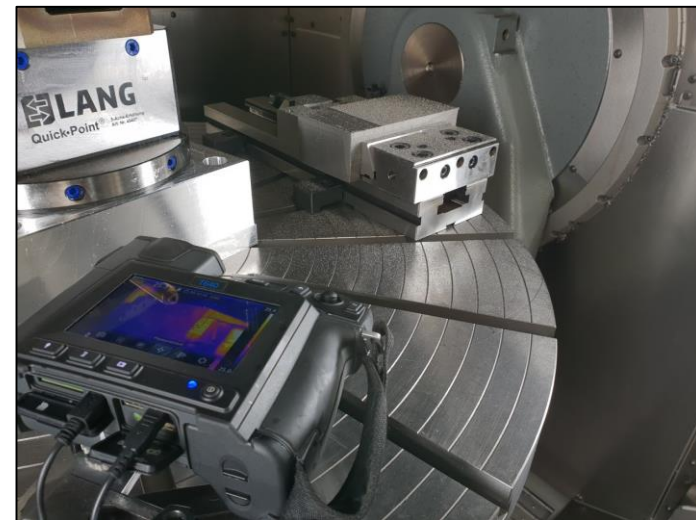
The thermal imaging camera was clamped to the machine bed with the lens aimed towards the titanium workpiece. With the Air Turbine in the spindle the tool was measured using the BLUM Laser Measurer.

Experimental setup

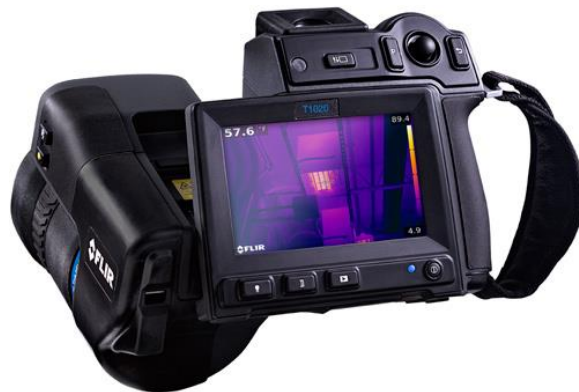
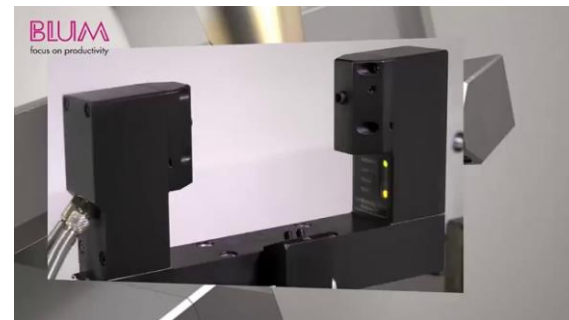
- Firstly, a thermal imagnie camera was set up in the machine for temperature recording.
- Also, the BLUM laser measurer fitted inside the machine was used to take five tool length measurements before and after cutting to check for thermal growth of the spindle. Five measurements were taken and an average taken to account for measurement variation.

The aim was to show any increase in temperature over time by the spindle running continuously. Also, the tool length measurements would show if the size of the tool increased as a result of thermal expansion.

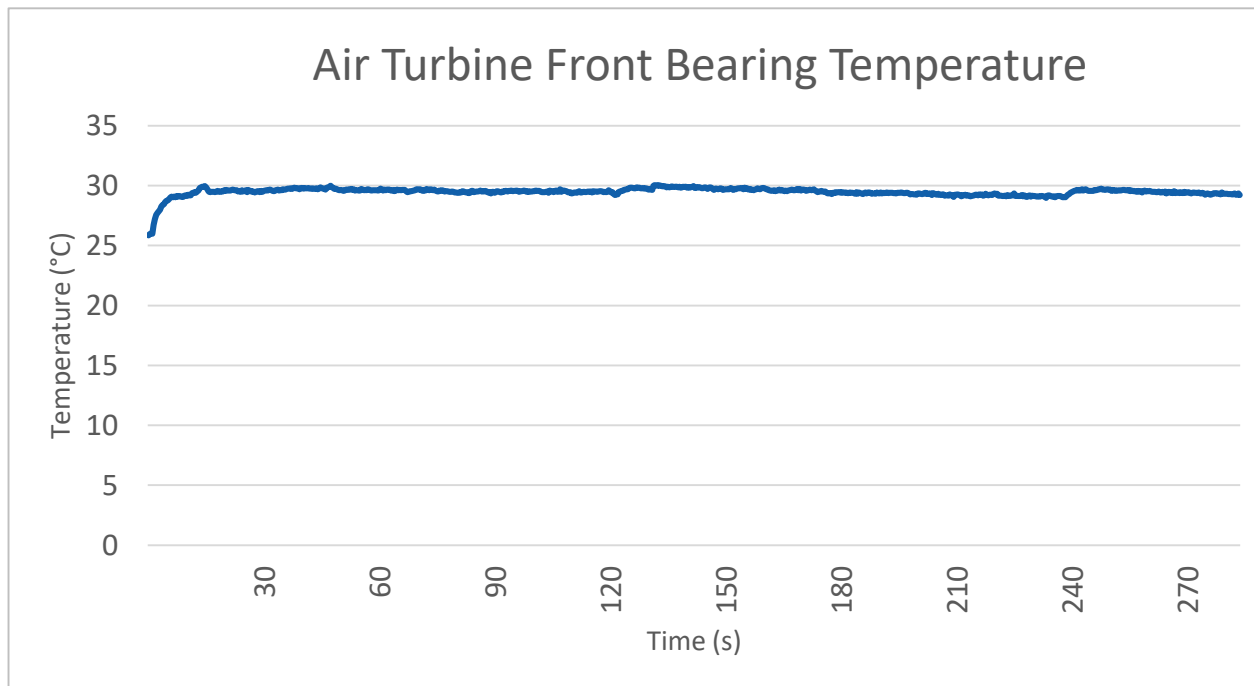
The camera was able to record continuously for the first 4.5 hour period.

Below is a graph showing the temperature at 20 second intervals, as can be seen there was a small temperature rise at the start as the spindle went from ambient 26°C to a steady state operating temperature around 30°C.

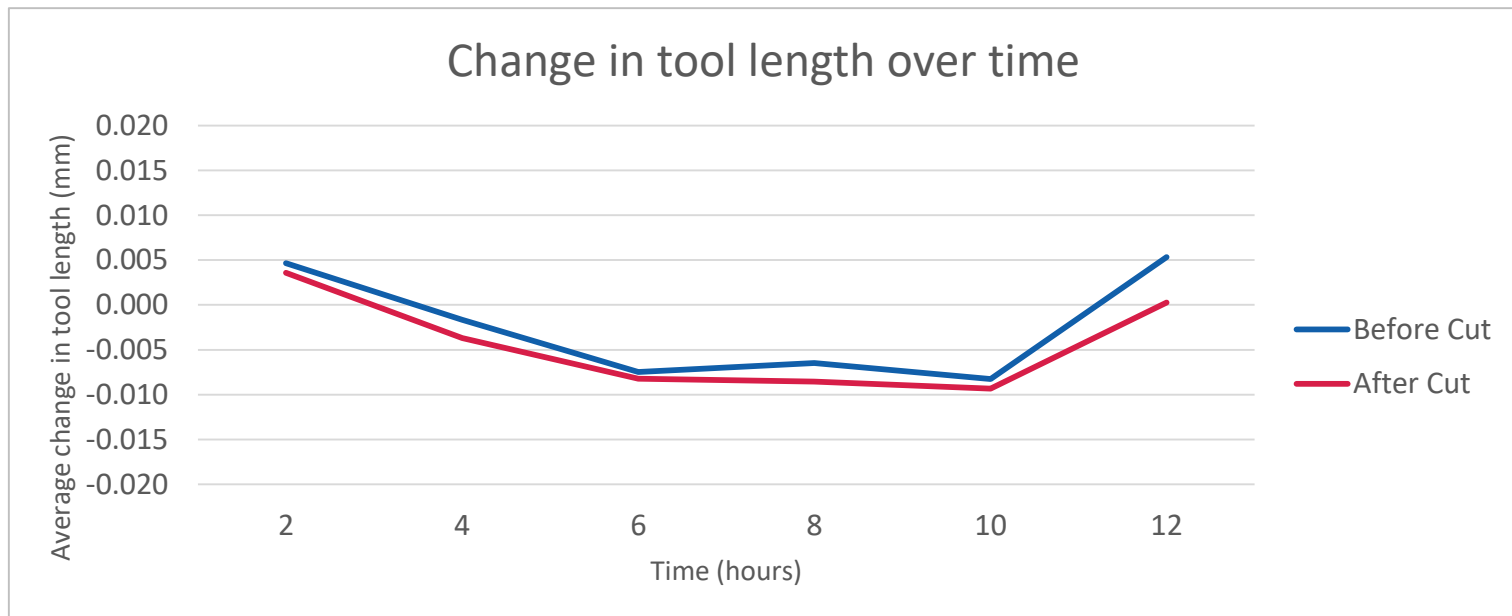
Below is a graph showing the average change in tool length from the original measurement taken at the start of the test. Five measurements were taken before and after the programmed cut in order for an average to be calculated. The accuracy of the Blum Laser is $\pm 2.5\mu\text{m}$.

The maximum change was $-9\mu\text{m}$, taken after the cut at 10 hours. The gradual reduction over the test could be explained by tool wear due to dry cutting titanium. The small increase towards the end is due to built up cutting edge which was observed at the end of the test.
